## MEMORANDUM

**Project:** 090557-01

**Re:** Post-TCRA Quarterly Inspection Report – October 2013 Inspection

This document reports the results of the October 2013 quarterly inspection of the armored cap cover, fencing, and signage installed for the Time Critical Removal Action (TCRA) at the San Jacinto River Waste Pits Superfund Site (TCRA Site). Figure 1 shows the location of the TCRA site.

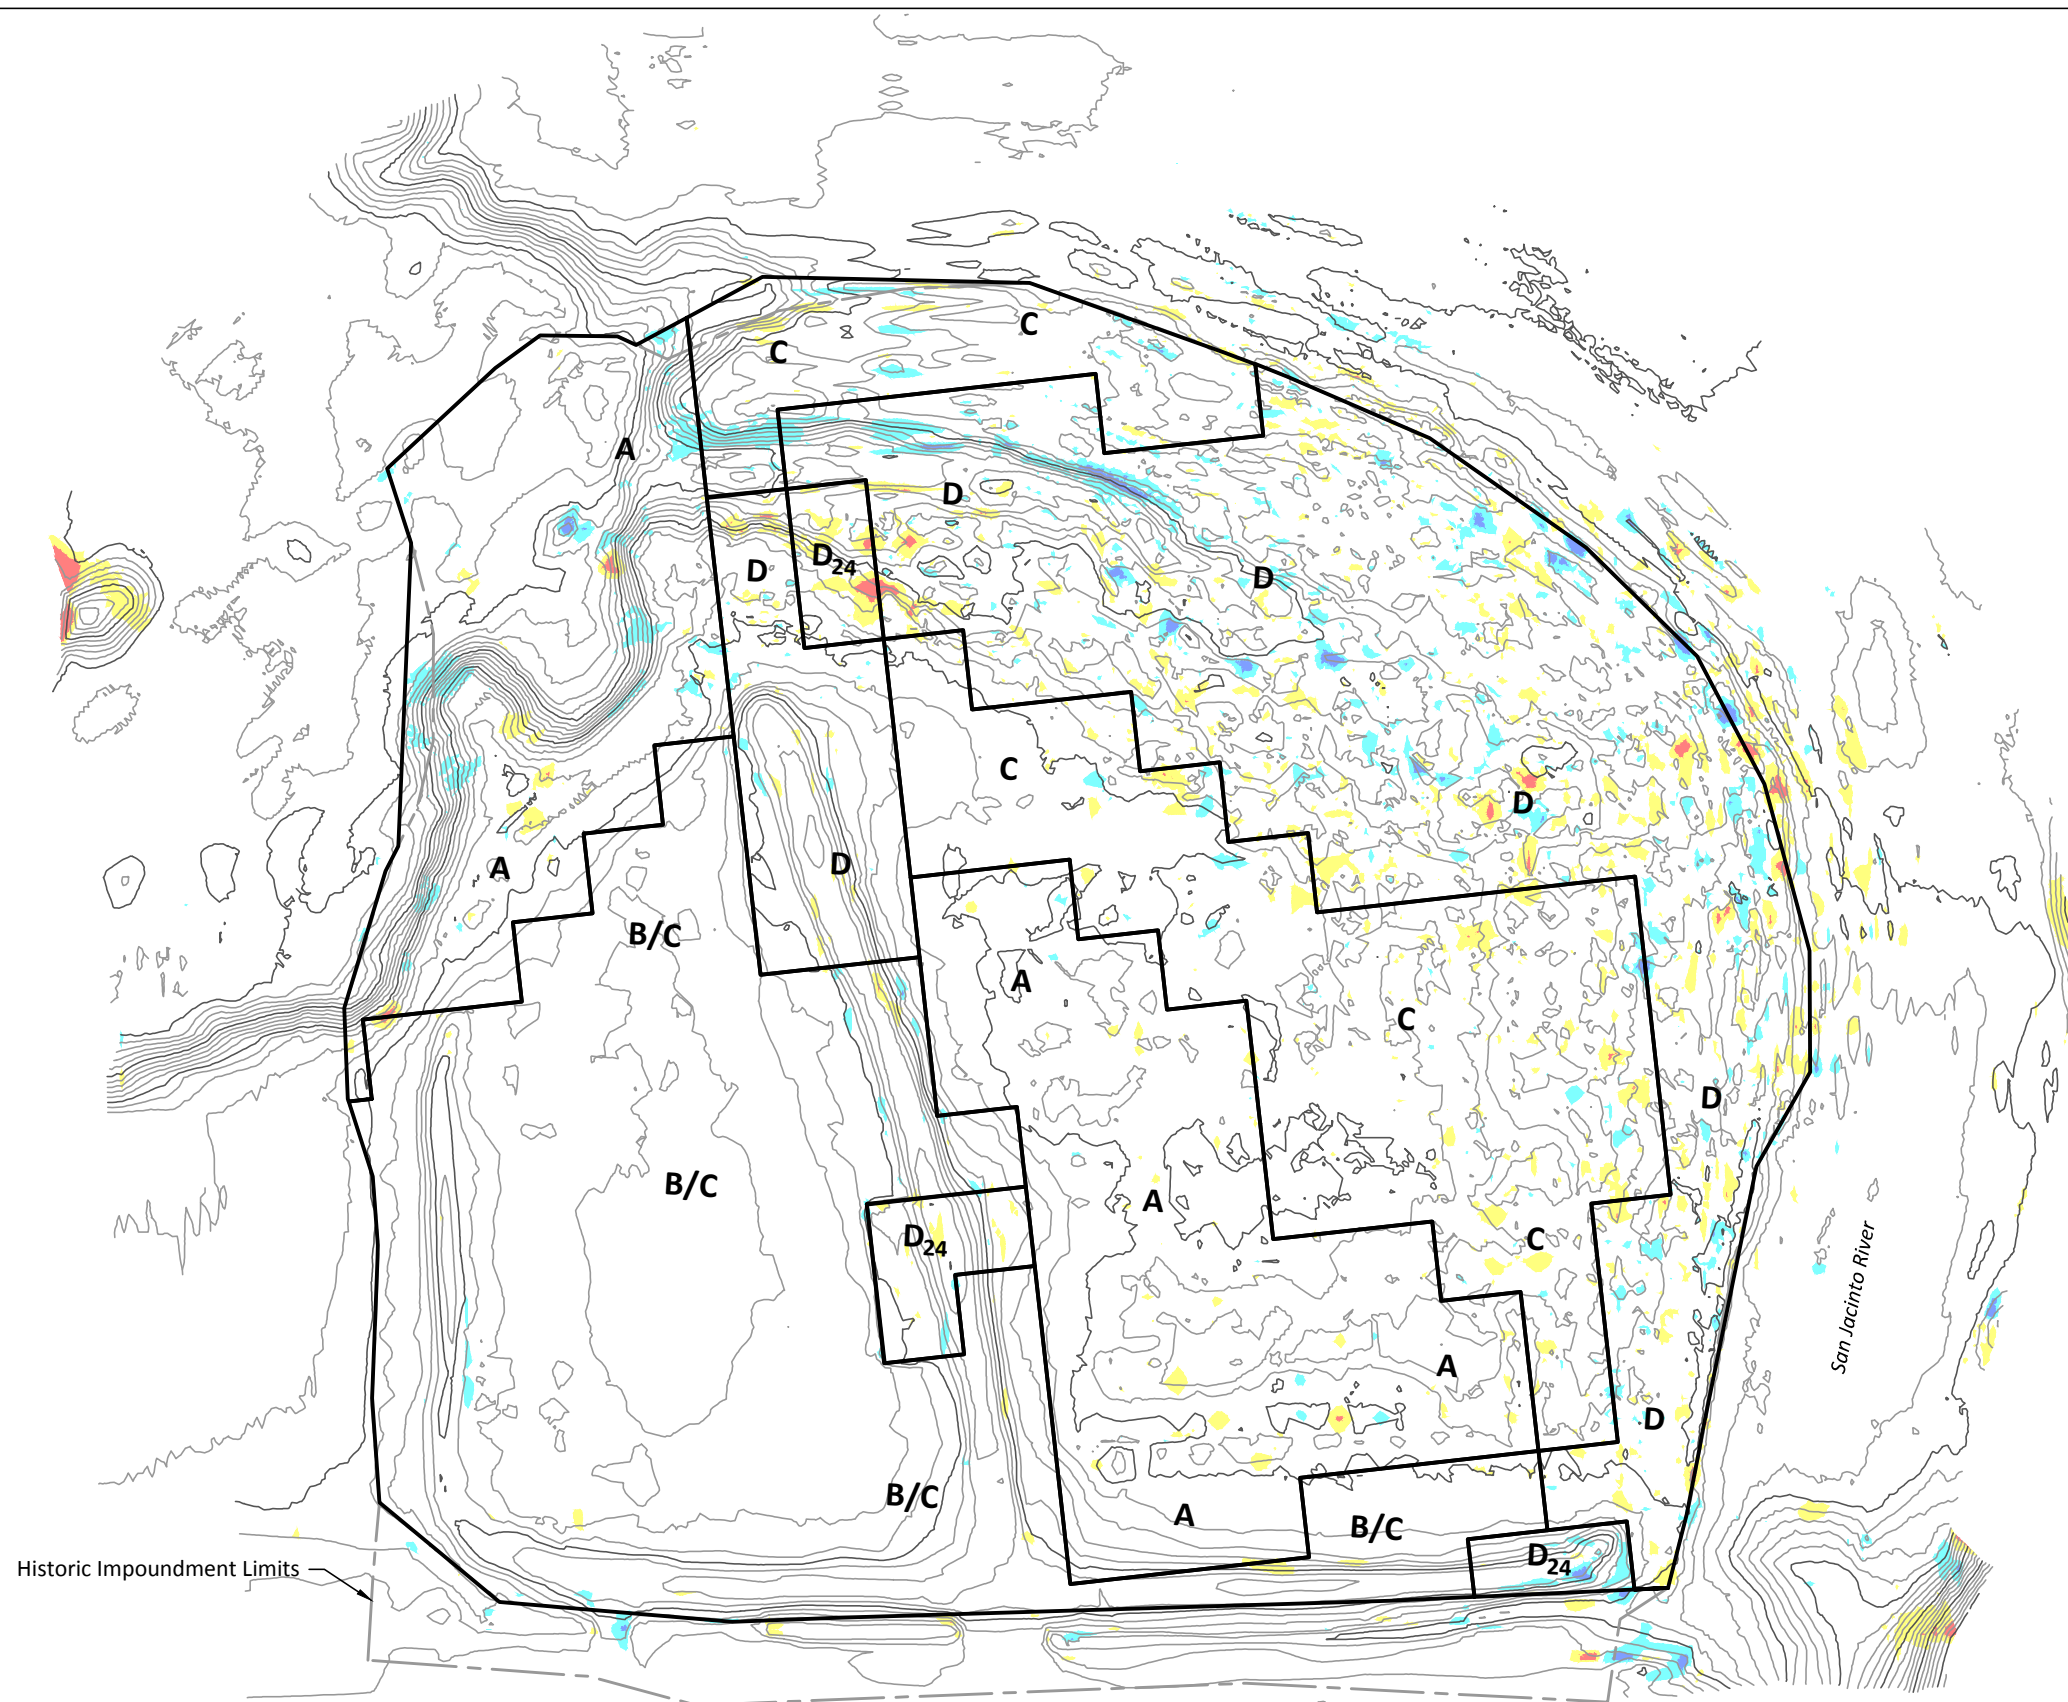
The survey datasets from July and October 2013 were compared to evaluate the differences in the top of the armor cap elevation between surveys. These differences are shaded and shown on Figure 3. The survey results indicate there continues to be sedimentation/deposition on the surface of the armored cap, as may be expected in a fluvial system like the San Jacinto River.

Manual probing of armored cap thickness is required at areas identified by the topographic or bathymetric surveys as more than 6 inches lower in elevation than during the prior survey over contiguous areas of 30 feet by 30 feet. When the October 2013 hydrographic survey was compared to the July 2013 survey, the results indicated that there were no areas that met the manual probing requirement. Therefore, no probing was conducted as part of the October 2013 inspection.

The small areas identified as increases and decreases in elevation can be attributed to the horizontal and vertical accuracy of the survey, minor shifts in track line location from the baseline survey, elevation data recorded in the crevices between rock surfaces, or other related measuring inaccuracies. The potential for these inaccuracies to exist was confirmed by the surveyor after reviewing the data collected hydrographically during this inspection versus the surveys taken in July 2013.

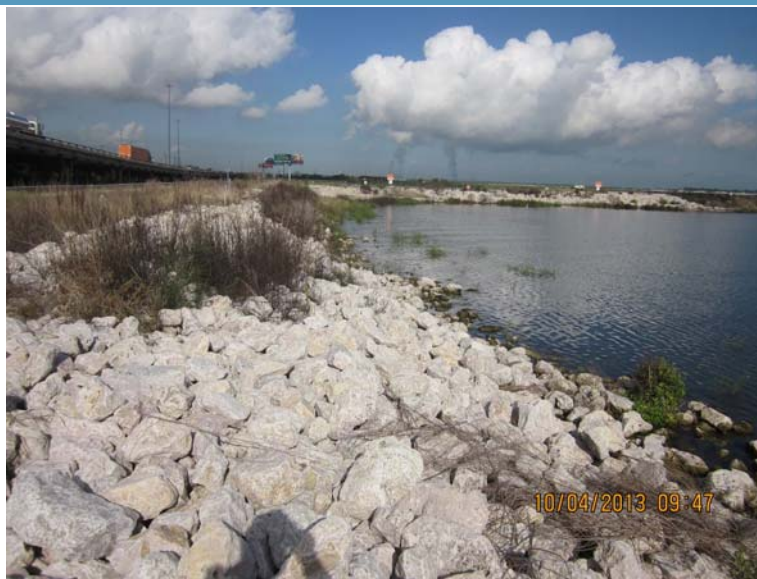
Photo 01: Vegetation and signage along southern and central berm (view southwest)

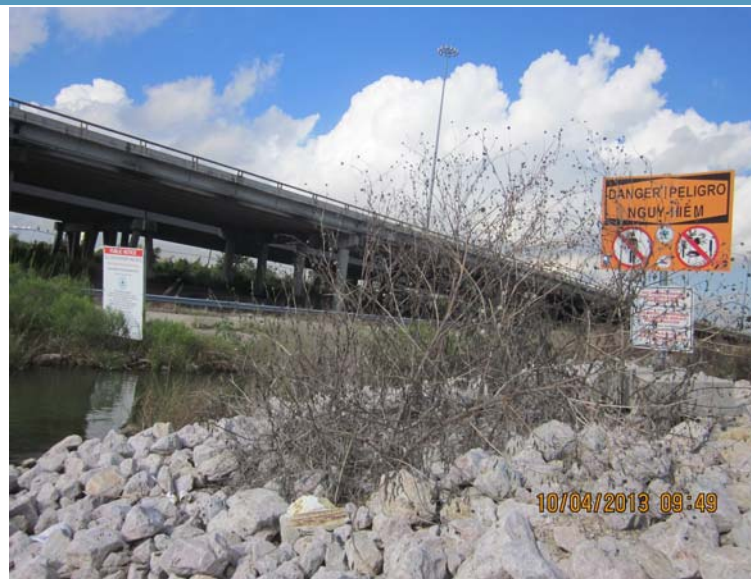
Photo 02: USEPA public notice sign, dying vegetation and signage at eastern end of southern berm (view southwest)

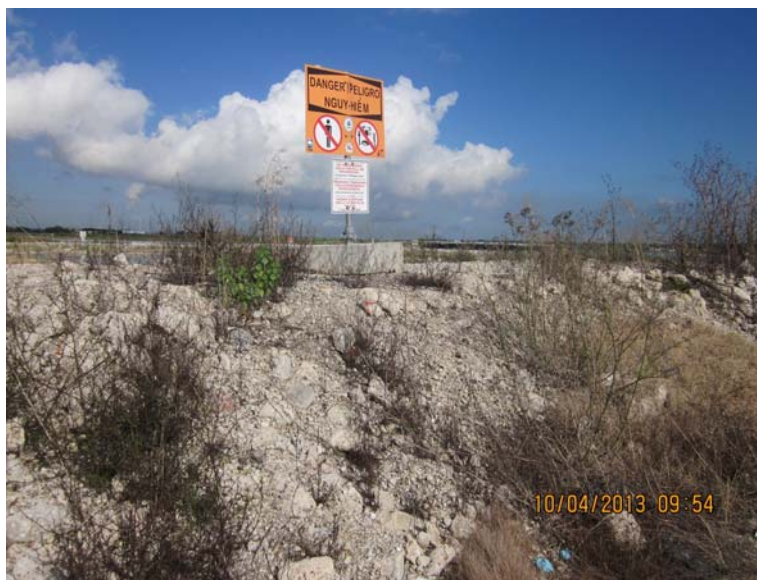
Photo 03: Signage and vegetation along eastern face of central berm (view northwest)

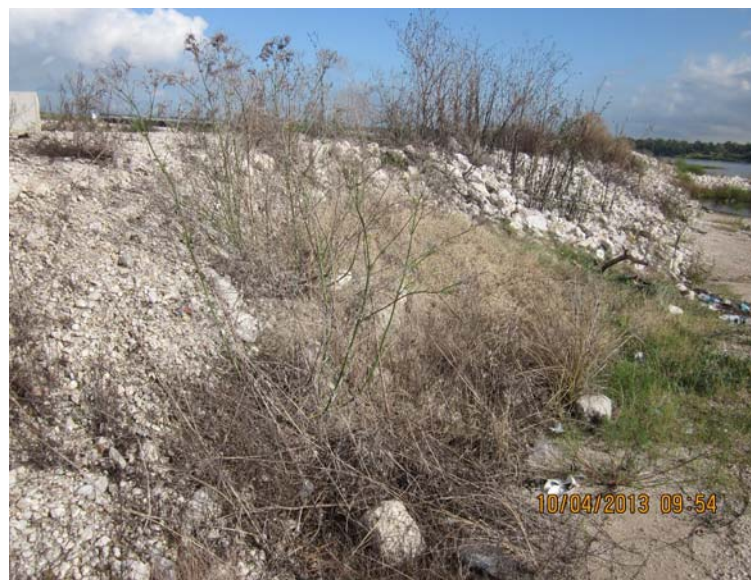
Photo 04: Vegetation along eastern face of central berm (view northwest)

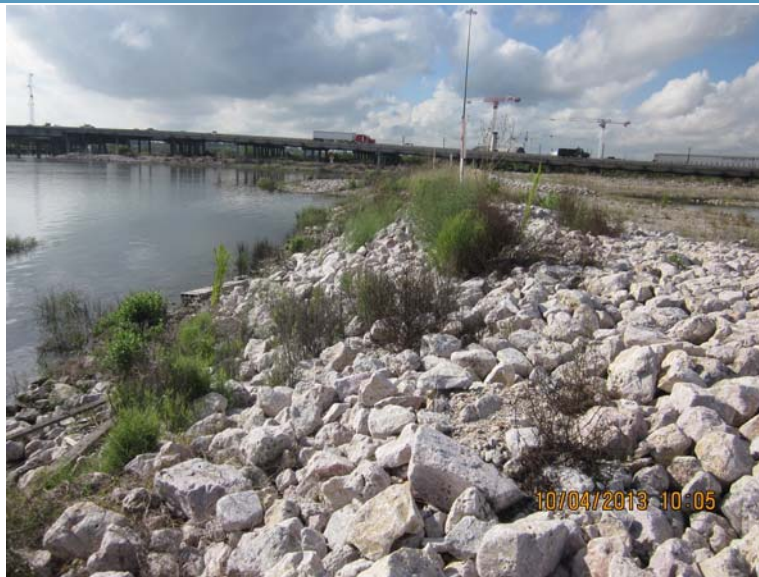
Photo 05: Vegetation along eastern face of central berm (view south)

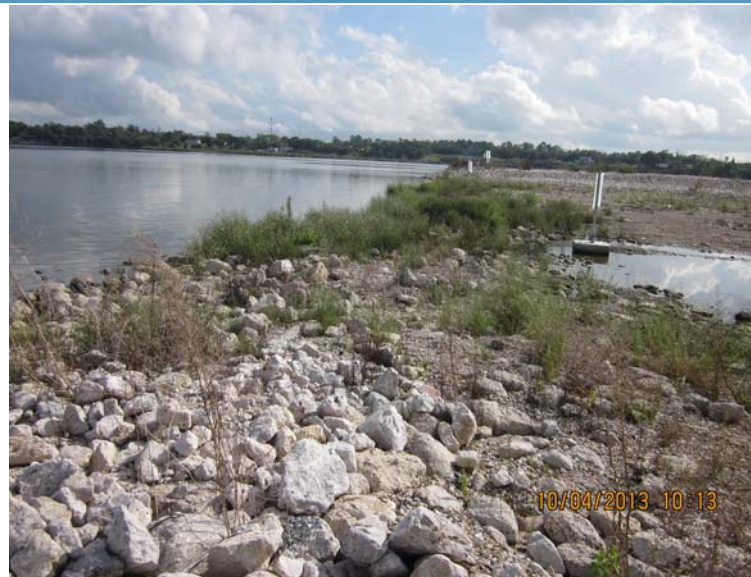
Photo 06: Northern edge of Western Cell with vegetation and standing water due to high tide (view northeast)

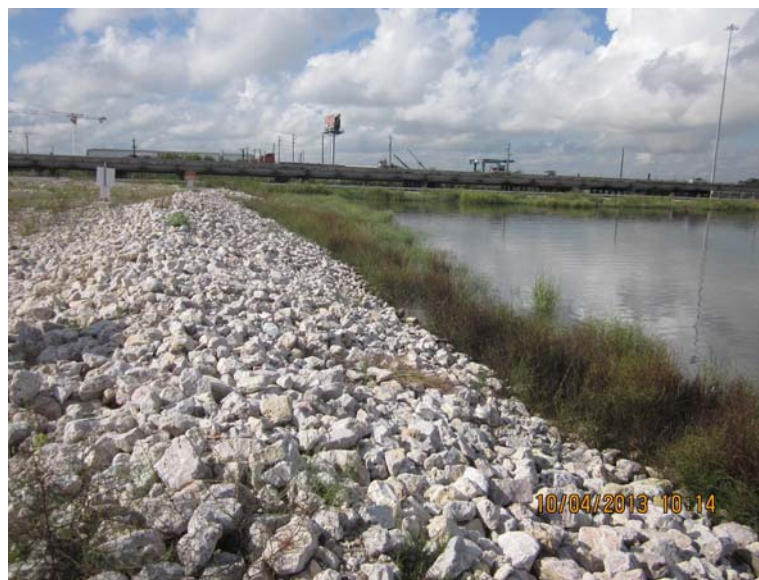
Photo 07: Vegetation and signage along western berm (view southwest)

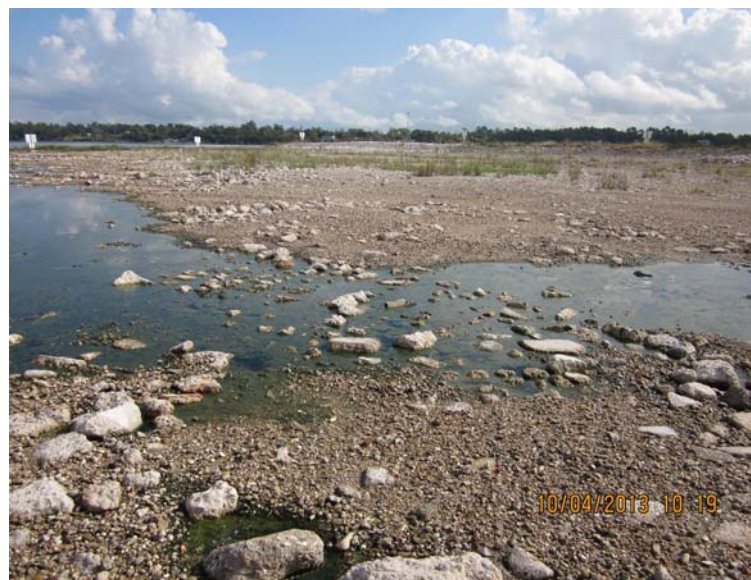
Photo 08: Standing water and biological growth on interior portion of Western Cell (view northeast)

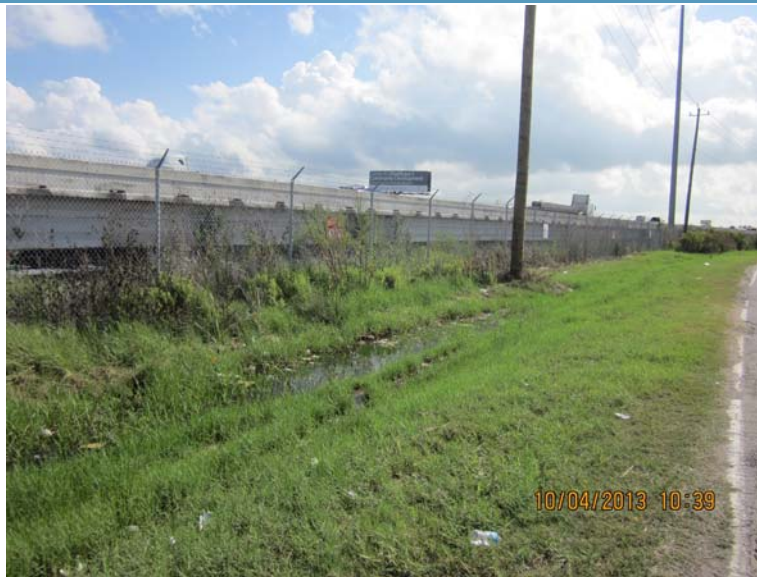
Photo 09: Warning signs and vegetation along perimeter fencing on west bank south of I-10 (view northeast)

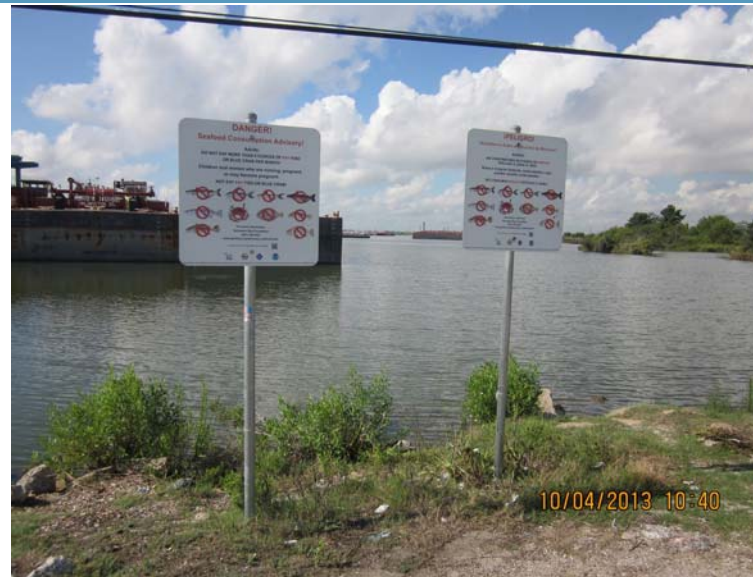
Photo 10: Fish consumption advisory signs on west bank south of I-10 (view south)

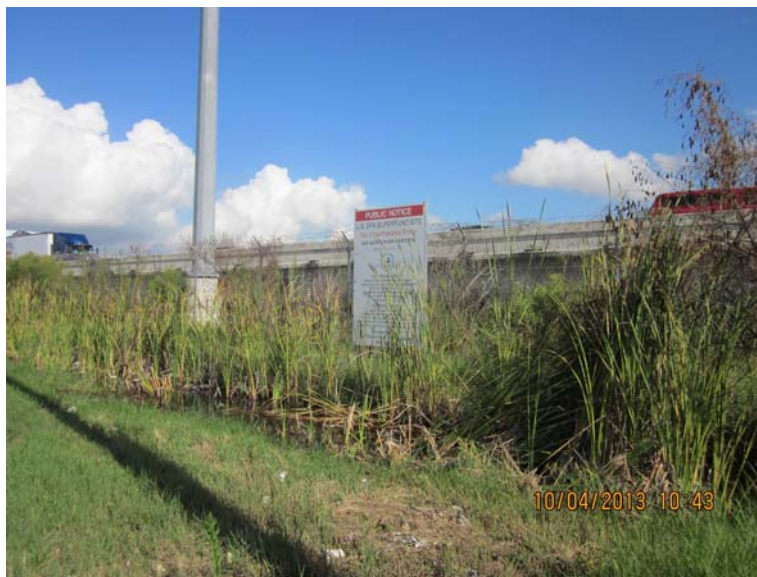
Photo 11: USEPA public notice sign and vegetation along perimeter fencing on west bank south of I-10 (view northwest)

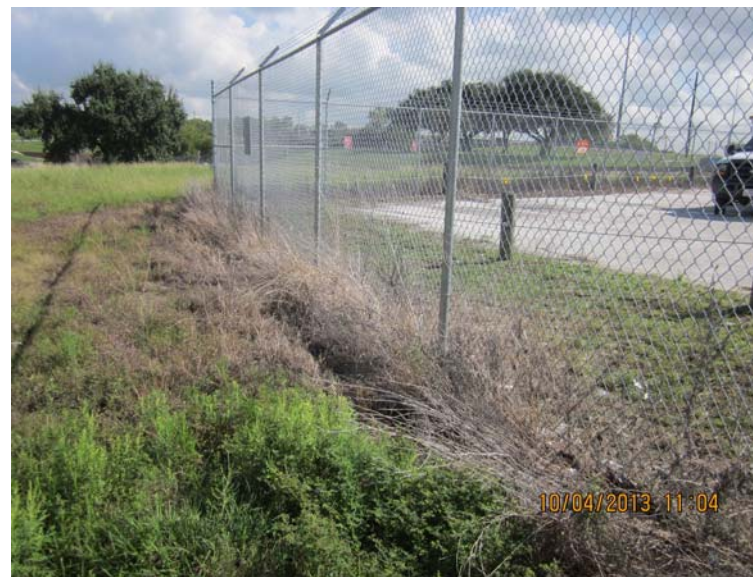
Photo 12: Warning signs and dying vegetation along perimeter fencing near parking lot on east bank south of I-10 (view northeast)

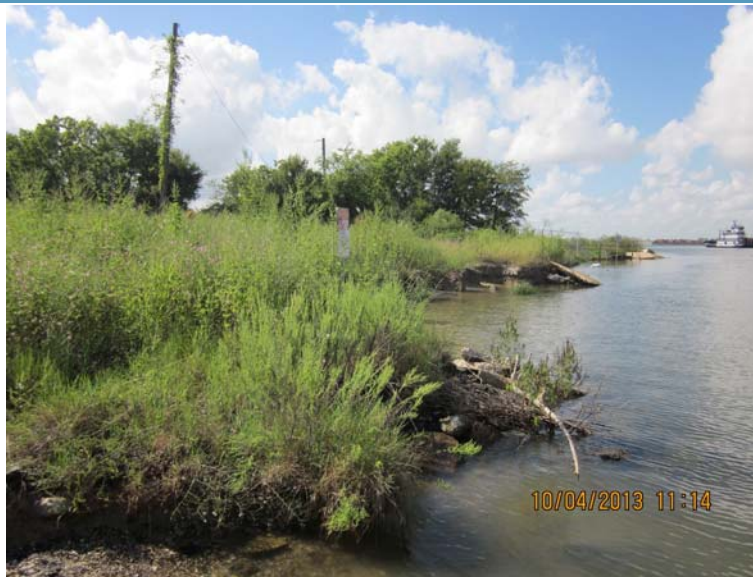
Photo 13: Warning sign along eastern bank south of I-10 (view south)

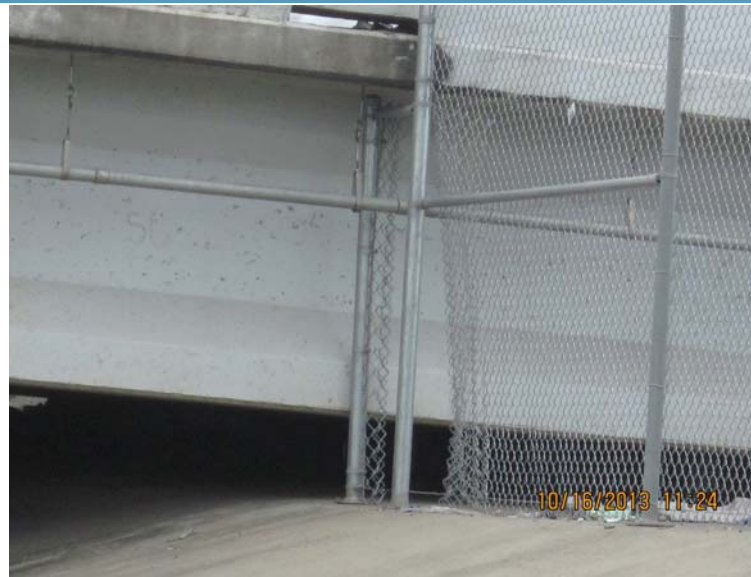
After receiving notification from Texas Department of Transportation (TxDOT) representatives that the fence had been cut on the south side of the east bank, a second inspection was performed on October 16, 2013. The fence maintenance contractor repaired the fence on October 23, 2013, and it was inspected on October 24, 2013. Photographs 14 and 15 show the damage and repairs, and are included in Appendix A. TxDOT staff continues to inspect the gates and fences and to patrol the area for trespassers. The vegetation along the southwest fence alignment facing Market Street has been mowed, and is dying off for the winter.

Photo 14: Opening in perimeter fencing where I-10 bridge and fencing meet along east bank south of I-10 (view northeast)

Other than the cut fence, no other TCRA construction elements were identified as deficient or damaged during this inspection event. Repairs to the fence were made; photographs of

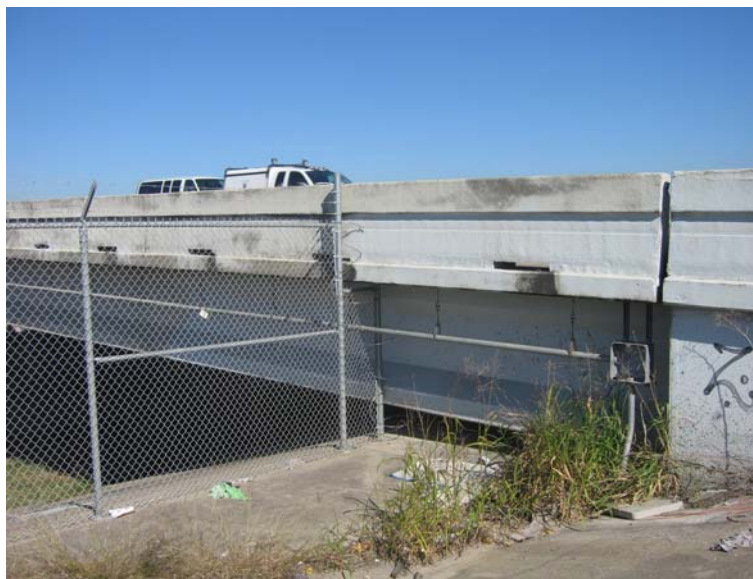
Photo 15: Repaired perimeter fencing with additional barb on east bank adjacent to and south of I-10 (view northwest)

the repaired fence are included in Appendix A. No maintenance was required to the TCRA cap in response to the October 2013 inspection.

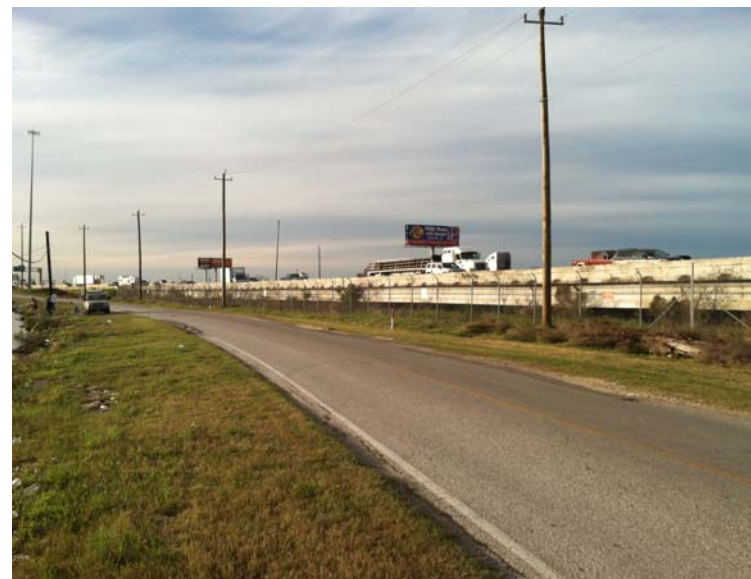
Photo 16: Recently mowed southwest fence alignment along Market Street. (view northwest) Photo taken November 8, 2013
